**UPPER PATUXENT RIVER WATERSHED RESTORATION ACTION STRATEGY (WRAS)
FORM 1 -- Catchment Information**

UPPER PATUXENT RIVER WATERSHED RESTORATION ACTION STRATEGY (WRAS) FORM 2 -- Site Information

Site Name: Parkview at Laurel Address: 9000-9010 Briarcroft Lane
 Site Owner: managed by Shelter Properties
 State Plane Coordinates of Site Centroid: X: 1356398 Y: 514624 Date: 3/25/03
 Personnel: PM Weather: sunny, 70F deg
 Area (ac): 7.7 Impervious Area (ac): 4.3
 Percent Impervious: 56% Soil Recharge Factor (S): 0.13
 WQ_v (required): 0.36 Re_v (required): 0.05
 Property Area (ac): 26.2 Property Area Included in Site: 29 %
 Amount of Catchment Occupied by Site: 46 %

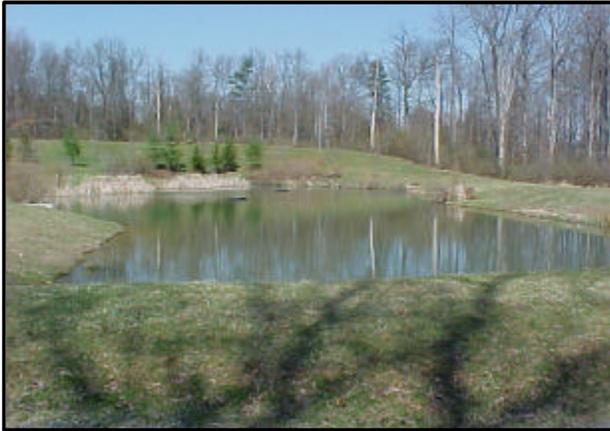
- No. 420 Description: looking north across pond
- No. 421 Description: looking upstream (west) at emergency spillway
- No. 422 Description: looking south at back (east) side of building
- No. 423 Description: looking south between buildings
- No. 424 Description: looking east at north side of buildings
- No. 425 Description: looking north at west side of building
- No. 426 Description: looking northeast to buildings and parking lot
- No. _____ Description: _____
- No. _____ Description: _____
- No. _____ Description: _____

Comments Water level is maintained too high (at crest of emergency spillway); a low-flow channel has formed in spillway.
